REGION 6 EXECUTIVE SUMMARY

TOPIC: San Jacinto River Waste Pits Superfund Site

DATE: December 17, 2015

PURPOSE: For Information – EPA Dive Team Inspection

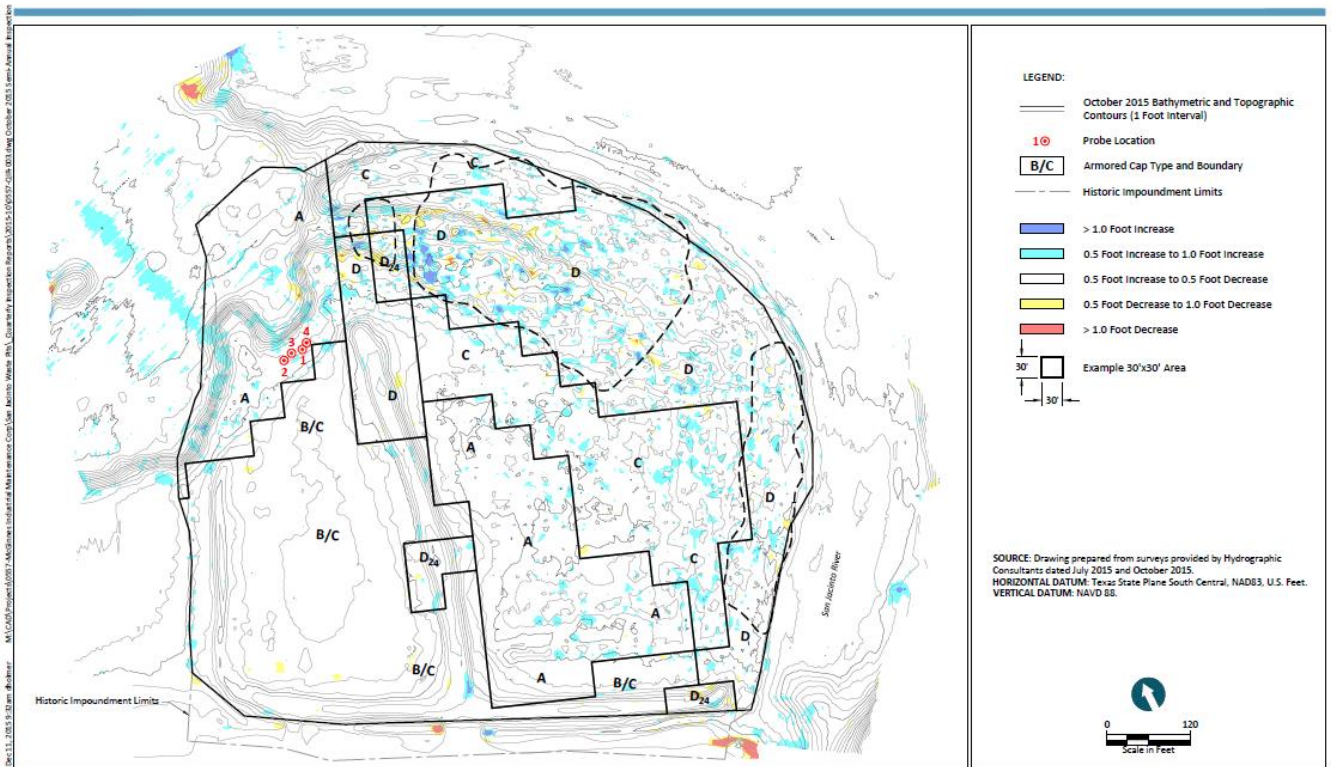
Figure 3
October 2015 Semi-Annual Inspection
Post TCRA Semi-Annual Inspection (October 2015)
San Jacinto River Waste Pits Superfund Site

- EPA dive team cap inspection completed Wednesday 12/9 & Thursday 12/10/15.
- Found gap in armor cap in Northwest area (see attached figure).
- Gap area unknown, but at least 17-feet across.

- Sampling in vicinity prior to cap installation showed dioxin as high as 20,000 ppt.
- Bathymetric surveys during inspections did not indicate any cap deficiencies. Inspections initially done quarterly & now done twice per year. No indication of subsidence. Last semi-annual inspection performed July 2015.
- Probing done following construction in 2011 found design 1-foot minimum cap thickness in gap area.

- Expect draft repair plan early next week.
- Repair cap as soon as possible.
- Sample sediment in gap area.
- Sample cap repair area during pore water sampling - January 2016.
- Develop enhanced inspection plan.
